# ParaDrain™ - Case History

## Slope Stabilization After Failure Wan Li, Taipei - Taiwan ROC

ParaDrain™ grade use: ParaDrain™ 100/15  
Client: Taipei County Government  
Design: Johnson Engineering Co. Ltd.  
Contractor: Fu-Yi Construction Co. Ltd.

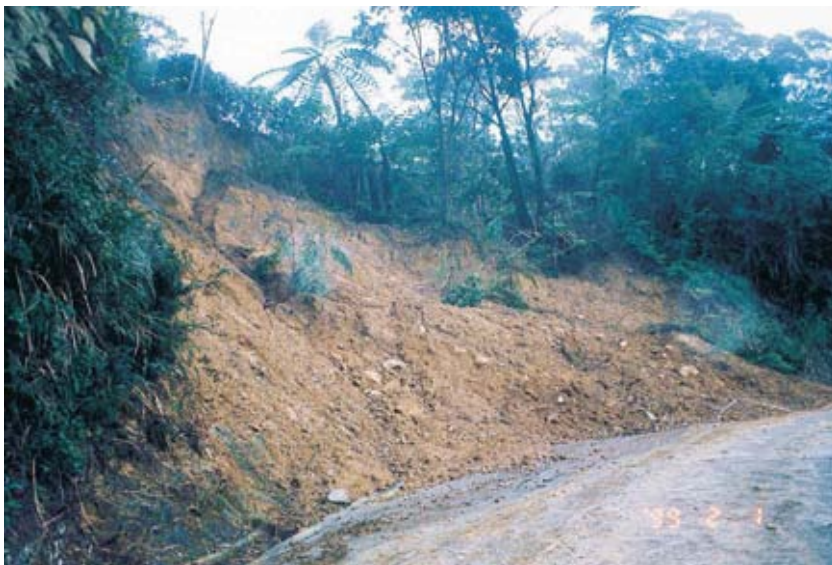
During the typhoon season a build up of pore water pressure in a section of slope on the uphill side of the single carriageway road coupled with generally poor drainage caused a collapse of the slope and consequent closure of the road. The technique of soil reinforcement using ParaGrid™ is a very common and popular means of effecting slope repairs in Taiwan.
